Revision Guide for AMD Family 14h Models 00h-0Fh Processors

Publication # 47534	Revision: 3.00
Issue Date: January 2011

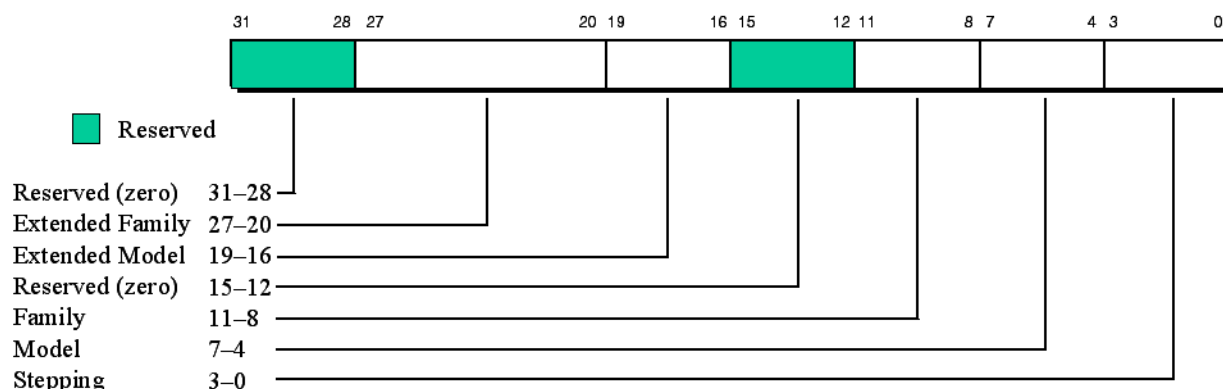
Figure 1. Format of CPUID Fn0000_0001_EAX

A processor revision is identified using a unique value that is returned in the EAX register after executing the CPUID instruction function 0000_0001h (CPUID Fn0000_0001_EAX). Figure 1 shows the format of the value from CPUID Fn0000_0001_EAX. In some cases, two or more processor revisions may exist within a stepping of a processor family and are identified by a unique value in D18F4x164 Fixed Errata Register (see page 14).
